Bravo 21 Transmissions

We have heard from some customers about the following random transmission issues. We will also address what has been done to date and what steps we have planned for the future with the drive system.

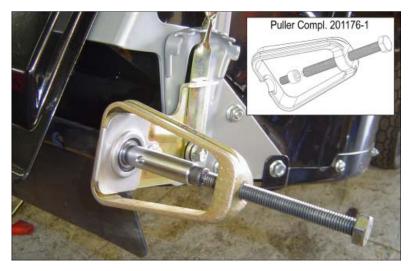
To make servicing the bearings in the rear wheel brackets easier the transmission axles have received a chrome finish. This prevents rust next to the bearing thus making it easier to remove the wheel bracket from the shaft. We also offer a wheel bracket puller (part #: 201176-1) that can be used to assist the removal of the bearing from the shaft.
